A. DESCRIPTION

Some subject vehicles may have an A/C refrigerant leak between the A/C pipe and the expansion valve. Dealers should inspect the joint part between the A/C pipe and the expansion valve for refrigerant leakage by using a black light. A yellow fluorescent dye is added in the refrigerant during production.

For vehicles that are found to have an A/C leak from the refrigerant leak inspection, replace the O-rings of the A/C pipes (HI and LO) with a modified one (with enlarged diameter). If a leak still exist, replace the A/C pipe (HI) with a new one.

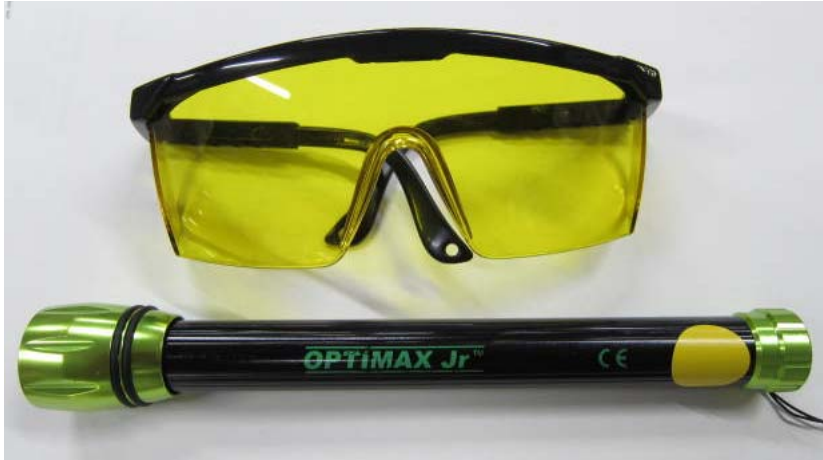
3. Direct a black light toward the joint part between the expansion valve and the A/C pipes (HI and LO) and look for a refrigerant leak.

- If ANY yellow color dye leak is detected, it is NO GOOD. Check the VIN list with “NG”. Inspection is complete. Go to REPAIR PROCEDURE.
 - If NO yellow color dye leak is detected, go to next step.

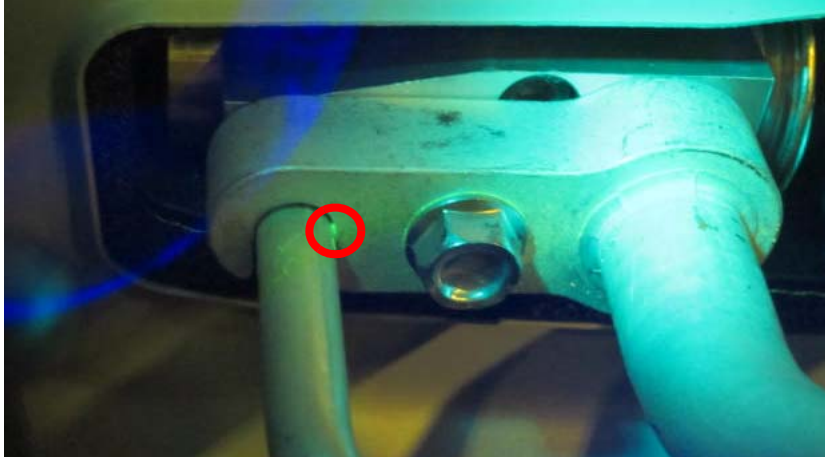
What a yellow dye leak looks like with a black light:

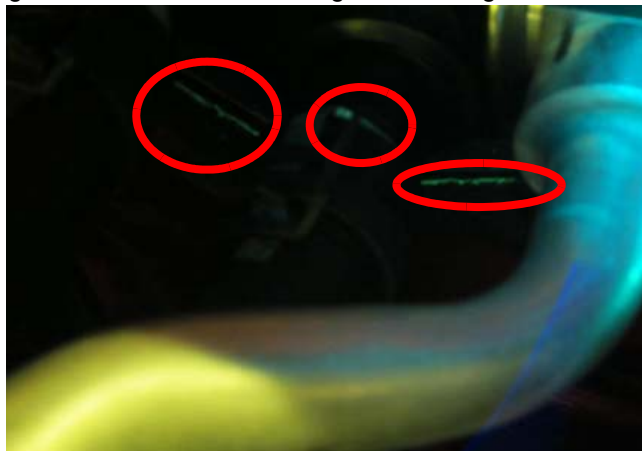
CAUTION: The both-side adhesive tape of the sponge around the expansion valve reacts to the black light and emits light. DO NOT mistake this light for a refrigerant leak.

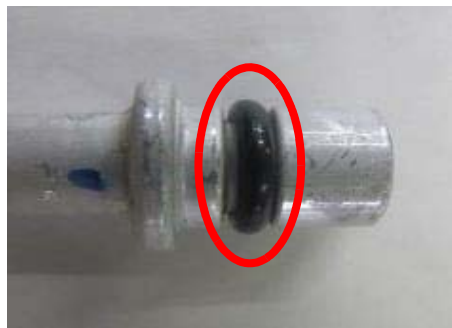
5. Remove the O-ring from the A/C pipe (HI).

CAUTION: Pay close attention so as not to damage the surface of the A/C pipe during the O-ring removal.

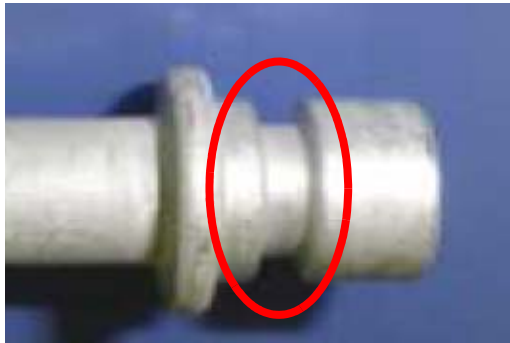
6. Make sure that the O-ring seating portion and the area around it are free from foreign material and refrigerant (fluorescent dye).

NOTE: If needed, clean the area off with brake cleaner. Make sure there are no fibers adhering to the pipe.

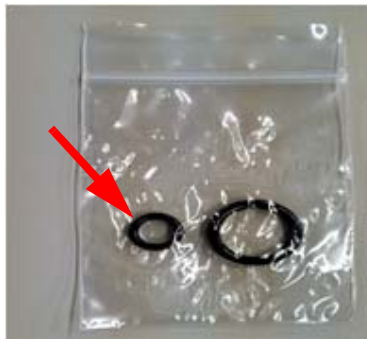
7. Install the O-ring (Small) of the O-ring kit to the A/C pipe (HI).

CAUTION: DO NOT wipe off the oil on the O-ring surface during the installation. If the O-ring looks dry, add a drop of oil to it.

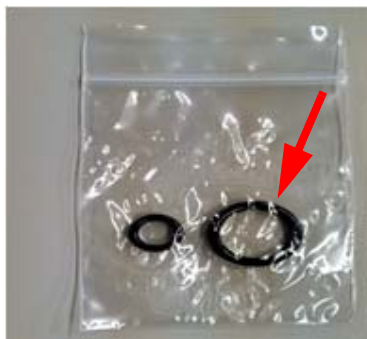
10. Install the O-ring (Large) of the O-ring kit to the A/C pipe (LO).

CAUTION: DO NOT wipe off the oil on the O-ring surface during the installation. If the O-ring looks dry, add a drop of oil to it.
